## **The erosion of archaeology within reservoirs, ploughed fields, forestry and in other circumstances in the areas of the upper Clyde and Tweed rivers**

by Tam Ward, Biggar Archaeological Group  
January 2013

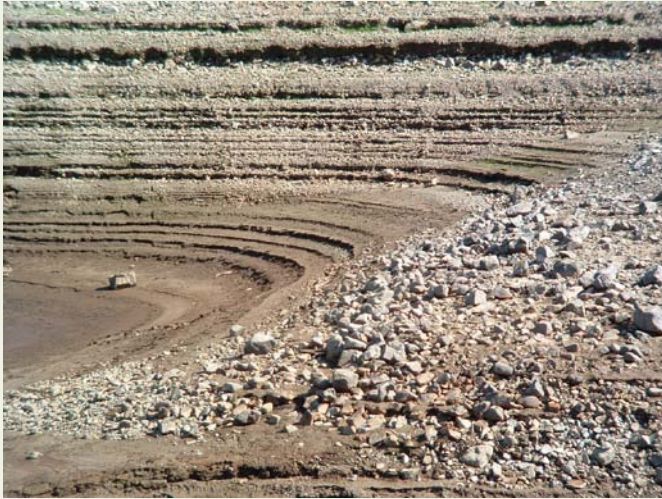
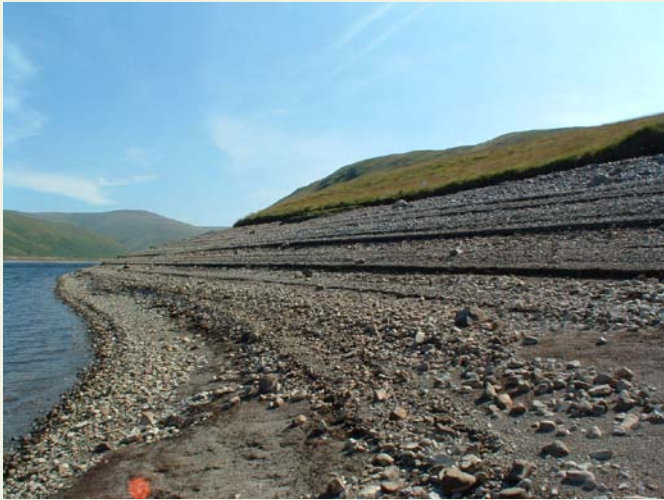
The most striking aspect of the landscapes when they once again become visible is the numerous facets of erosion and re deposition which can be seen. (PI's 4 – 6) The hydraulic effects of wave and current are evident on the shorelines, and by repeat visits it has been demonstrated that this is a dynamic process, which depends on the water level at a particular time, linked to weather conditions, and also the topography of the landscape and the prevailing wind. The variables of these four factors dictate what happens to the submerged land and the monuments or sites which lie on it.

**Plate 4 Fruid Reservoir beach lines**

**Plate 5 Fruid Reservoir beach lines**

**Plate 6 Fruid Reservoir beach lines**

The shoreline at the NW end, south of Chapel Burn is being scoured, beach lines forming at various levels when the water has been low (Pl's 4 – 6). The effects of scouring, and re deposition of gravels is quite strikingly obvious. This is where the two excavated UPS lay.

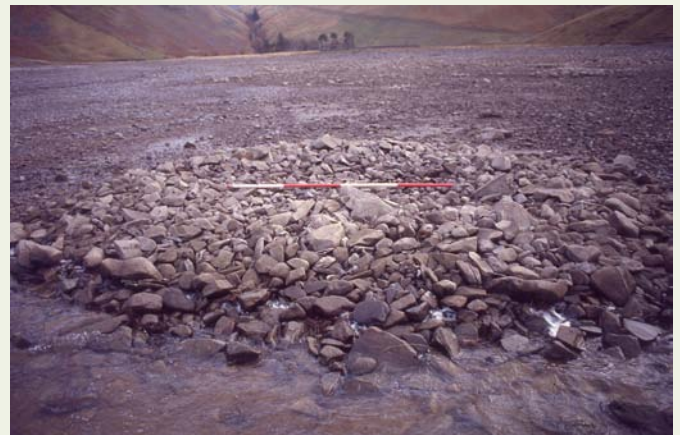
Talla Reservoir (PI's 2 & 3) was completed by 1906 and supplies water to Edinburgh, the area submerged is 300 acres. Pre historic and Post Medieval sites are located around its shores (Ward 2004) but because the reservoir was created in a narrow and steep sided valley the known archaeological sites are restricted to a narrow area of land on the north side with only a cairn and a burnt mound being known on the southern side, but these are high up on the hill face. However, a major pre historic funerary site is located at the east end, and this forms part of a large suite of pre historic monuments which now extend for an indeterminate distance below the water at that end (PI's 7, 8, 8a & 8b)(Ward 2004 *ibid*, Site 203).

Plate 7 Talla Reservoir Site part of Site 203

Plate 8 Talla Reservoir Site part of Site 203

Plate 8a Talla Reservoir Site part of Site 203

Plate 8b Talla Reservoir Site part of Site 203 (burial cairn)

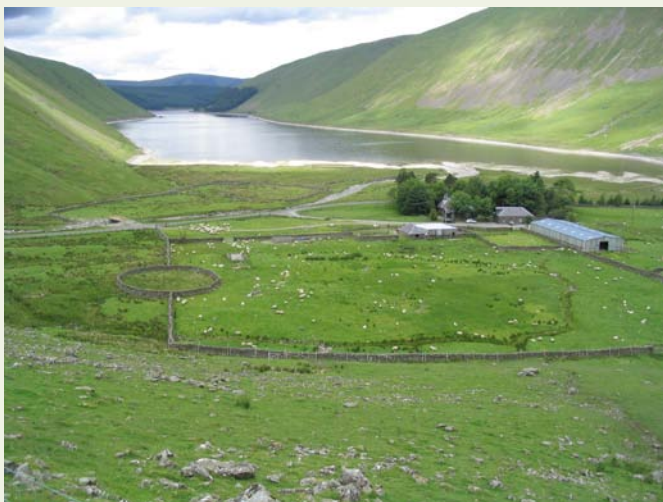
The east end is completely different as here the ground rises gently and evenly across the width of the reservoir from the valley floor (PI 9). This area has been adopted, probably in the Bronze Age, as a major centre for funerary monuments, perhaps serving much of the area of the upper reaches of the River Tweed (Ward 2004 *ibid*).

Fortunately the erosion so far recorded within the reservoir at this end is not great, but the soil and vegetation have been washed from the stone components of the monuments; mostly being a variety of ring enclosures and cairn types and with at least one burnt mound, the latter which has been almost completely dispersed. There is a hint of Mesolithic activity in the form of a few pieces of struck radiolarian chert, although the period concerned is not confirmed.

Plate 9 Talla Reservoir looking west

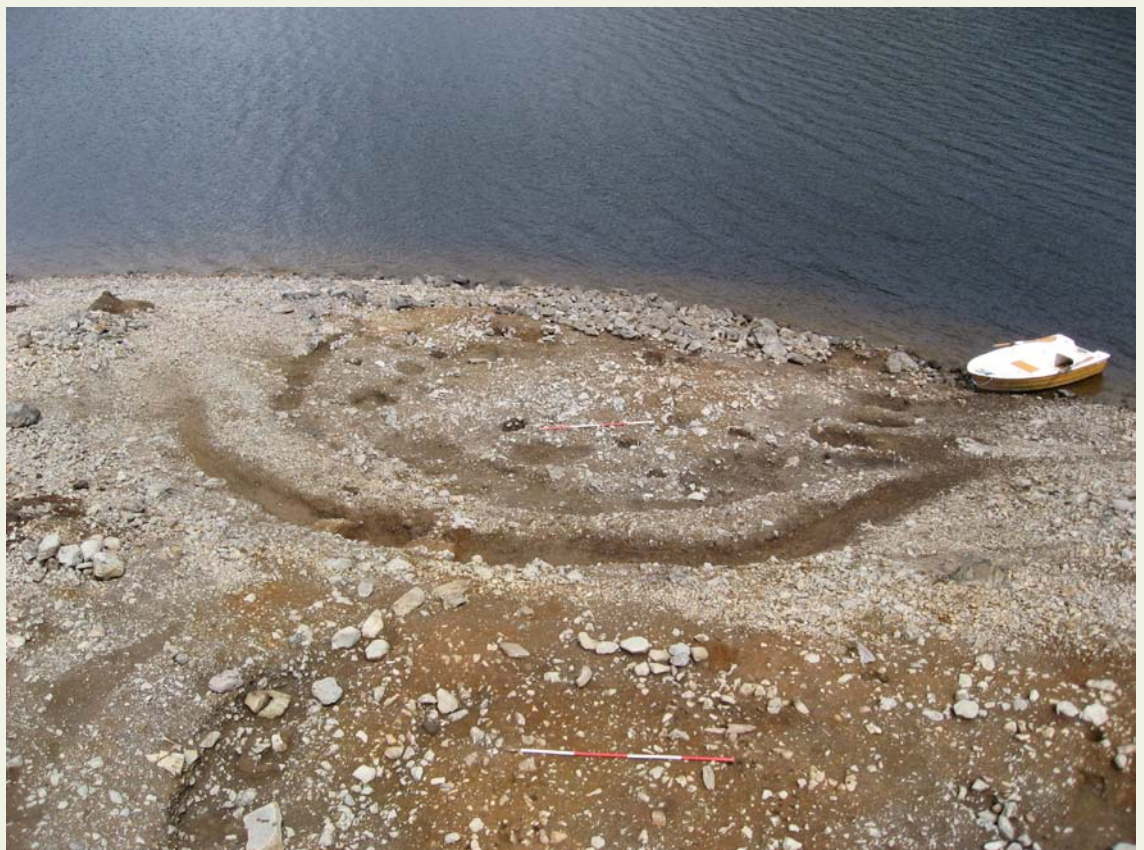
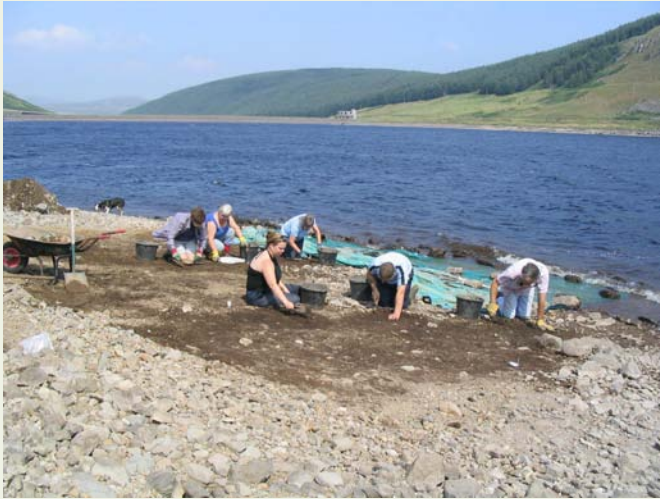
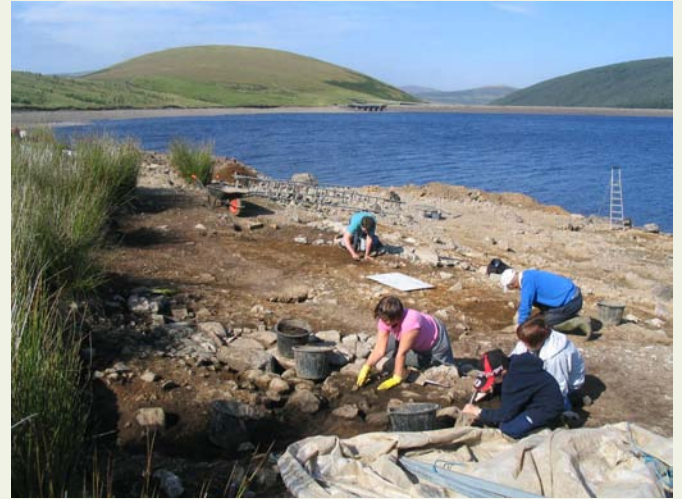
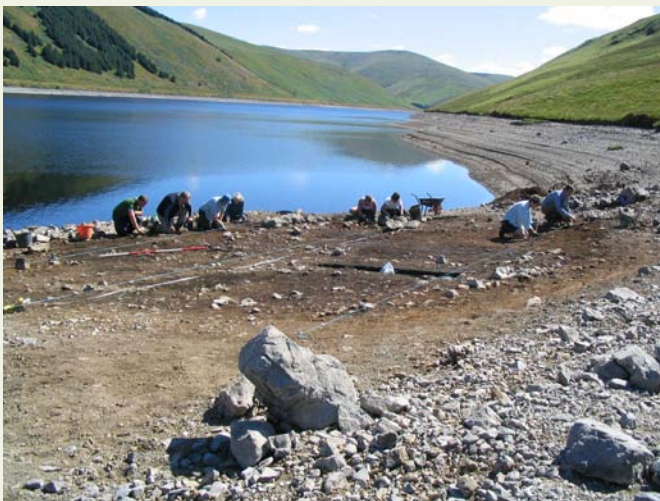
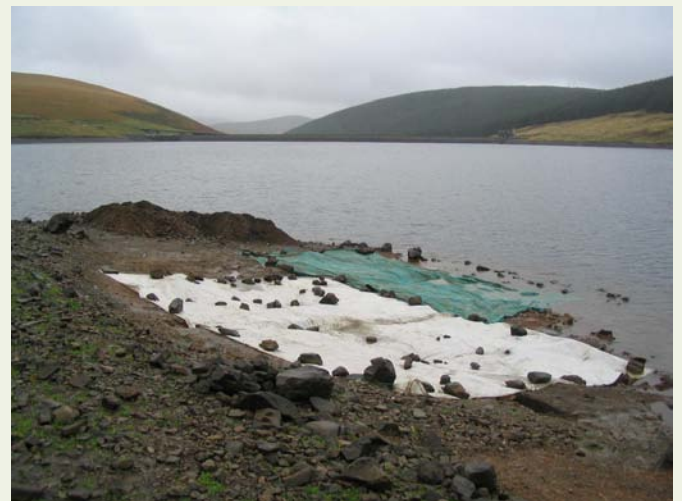
Inside the reservoir and on the southern edge of the confluence of Chapel Burn with the reservoir two further UPS were discovered by BAG, and as these were sites under active erosion they were excavated, producing excellent plans of the round timber houses which were dated to circa 1400BC (PI's 11 – 15) (Ward, 2013.1).

**Plate 11 Fruid Reservoir unenclosed platform settlement excavation**

**Plate 12 Fruid Reservoir unenclosed platform settlement excavation**

**Plate 13 Fruid Reservoir unenclosed platform settlement excavation**

**Plate 14 Fruid Reservoir unenclosed platform settlement excavation**

**Plate 15 Fruid Reservoir unenclosed platform settlement excavation**

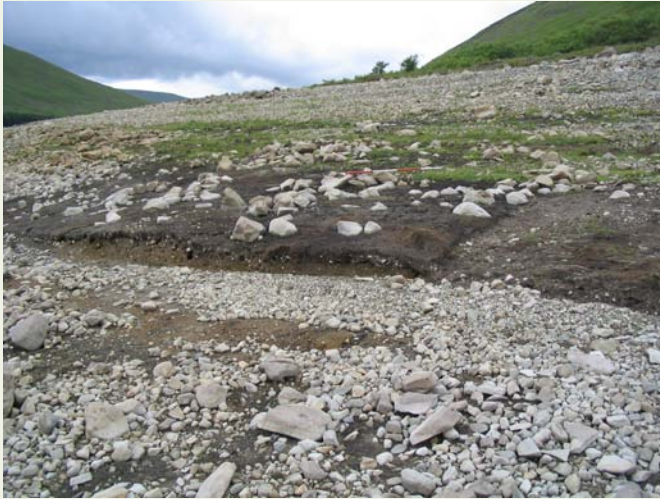
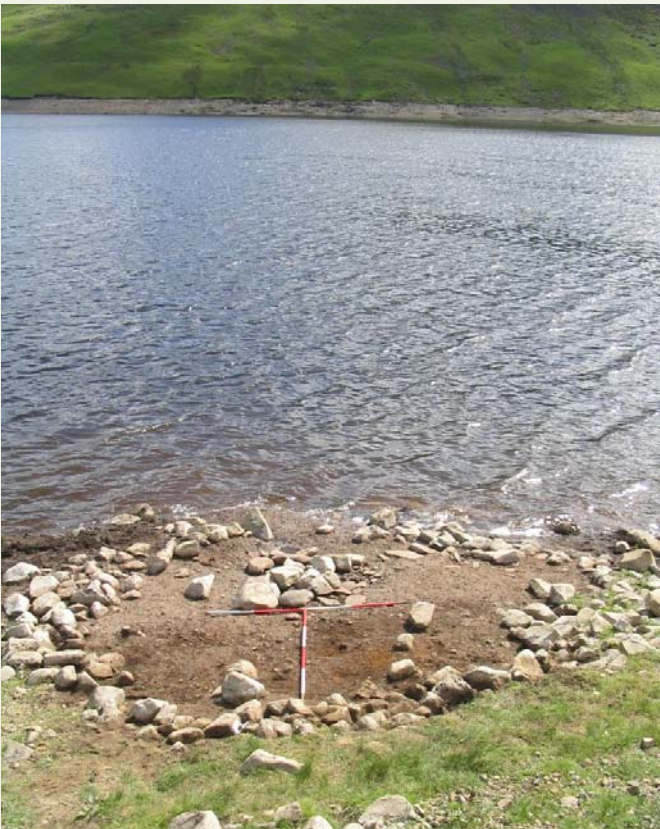
**Plate 16 Megget Reservoir showing erosion scarp at monument**

**Plate 17 Megget Reservoir showing erosion scarp at monument**

Somewhat surprisingly there is severe erosion taking place at the west end below Craig Head (PI 16), despite the fact that the prevailing wind should come from that direction, certainly the beach edges below the road side plantations are being scoured severely, Late Neolithic pottery has been found here, and several lines of badly scoured ground lie below the water, it may be that southerly winds causing high waves and coming via Winterhopeburn account for that. The only time BAG have investigated the reservoir was during a prolonged period of low water levels in 2004.

Plates 16 and 17 show a circular site with the scarp against it caused by wave action at that level.

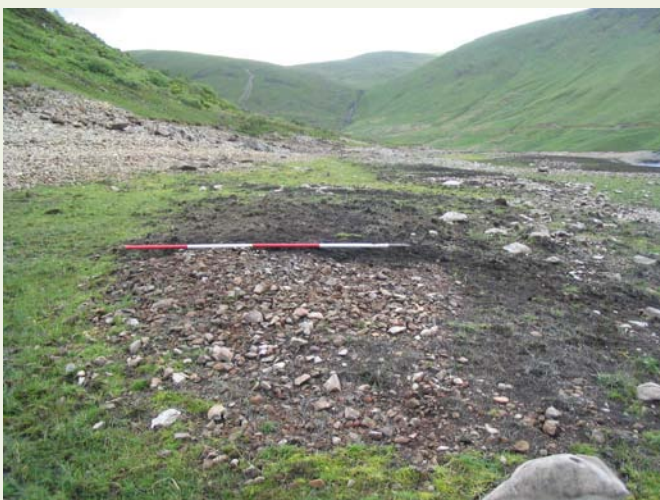
**Plate 18 Megget Reservoir showing erosion of burnt mound**

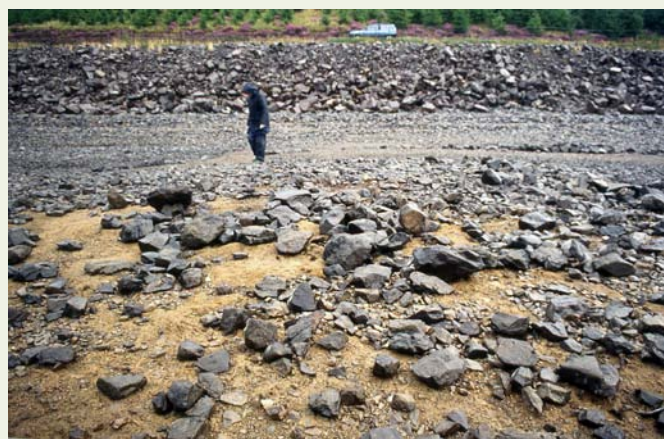
**Plate 21 Camps Reservoir showing erosion of enclosed cremation cemetery**

Severe erosion is taking place against the edges of the reservoir nearly everywhere (PI 21) except for the end of the southern branch where the ground rises gently to Campshead. It would appear that the banks extending from each end of the dam wall have been quarried as the ground drops into the reservoir extremely steeply.

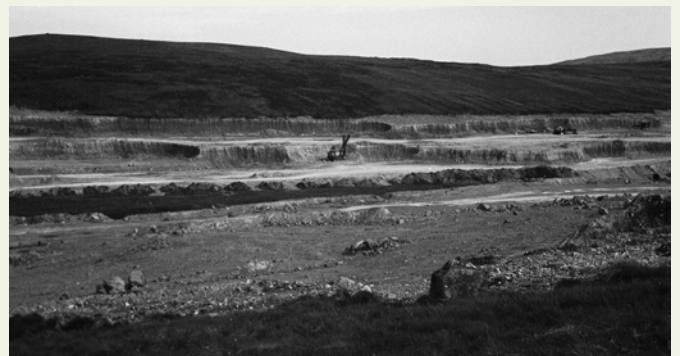
A large tract of the reservoir area was quarried for dam material (PI 22) and fortunately a photograph of this survives at Biggar Museum (PI 23). The photograph shows the excavation of the entire west face of Sweetshaw Rig and down into the valley floor and across to the east side of the reservoir. During this operation a massive volume of peat was extracted from within the reservoir area and doubtless will have scooped away archaeological deposits.

Plate 23 Daer Reservoir showing quarrying operations

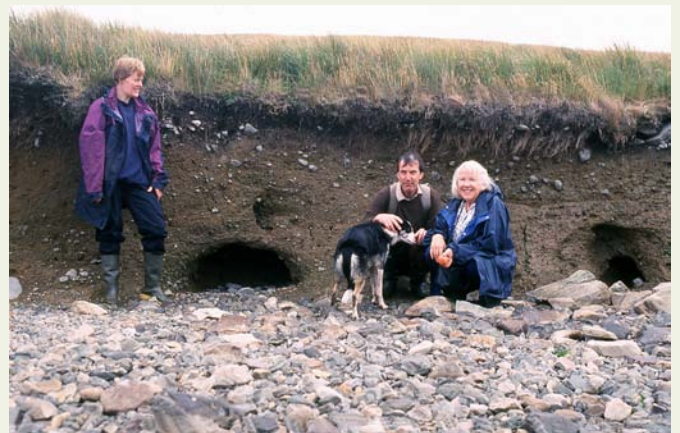
Severe erosion is taking place at the east side below Sweetshaw Farm (PI 24) and also around the area of a natural mound at Kirkhope Burn. The edges all around the reservoir are generally subject to erosion to some extent or other as this reservoir does fluctuate in water levels in most years. The least affected areas for erosion are at the southern end of the west branch where silting takes place from the Daer Water when in flood.

Plate 24 Daer Reservoir showing erosion of edge

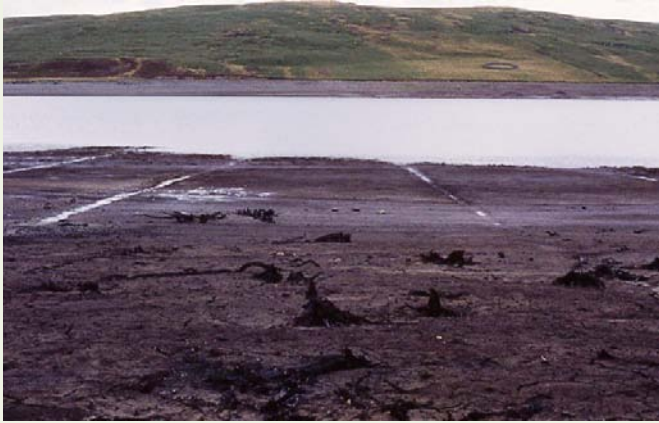
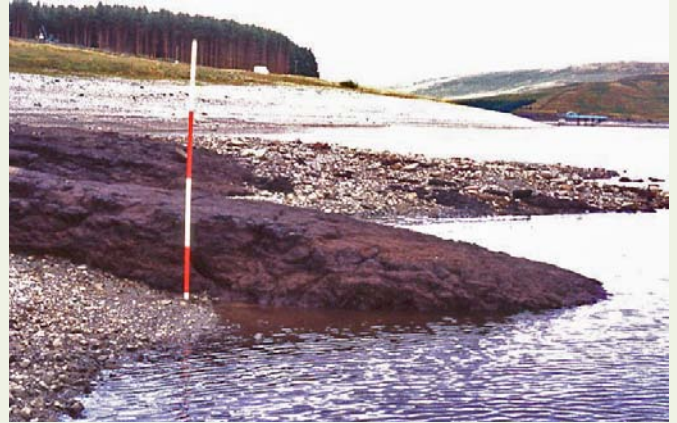
**Plate 25** Daer Reservoir showing surviving peat and pre historic tree stumps

**Plate 26** Daer Reservoir showing remnant peat

A huge quantity of peat was removed from the reservoir area during construction, but some large patches of peat remain (PI's 25 & 26) and these are shown on the plan (PI 22).

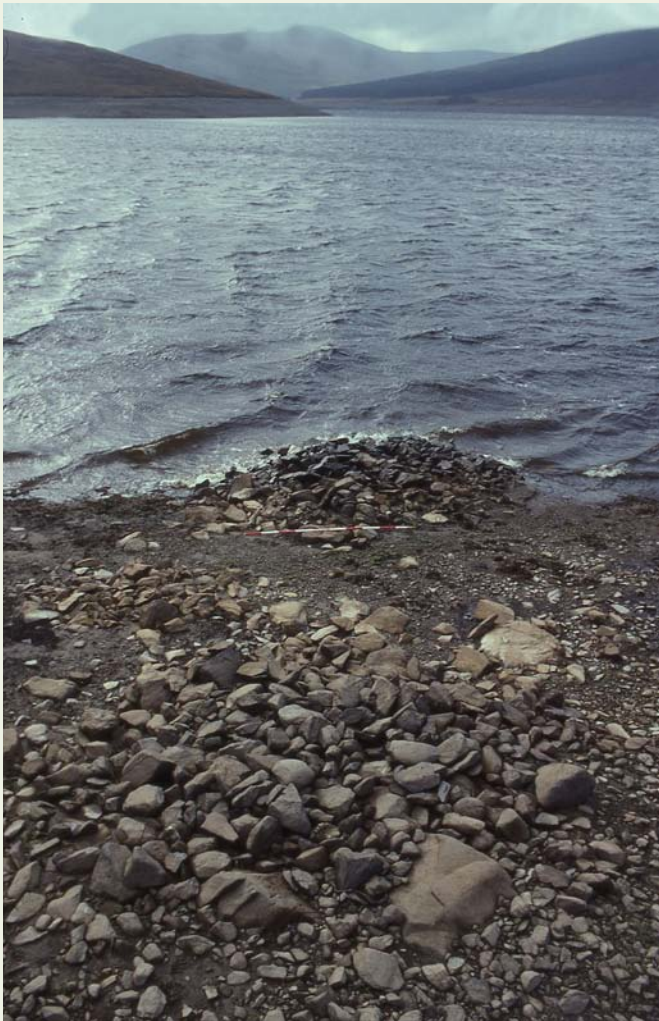
**Plate 27** Daer Reservoir showing cairns below water

The east side of the east branch has a series of cairns (PI 27) and Mesolithic sites (PI's 28 & 29) which for the most part are found further down slope from the reservoir edge, where the ground is constantly being cut away. Former cairns and a burnt mound along this shore have been dispersed and some damage has occurred to other cairns lower down when the water level was reduced.

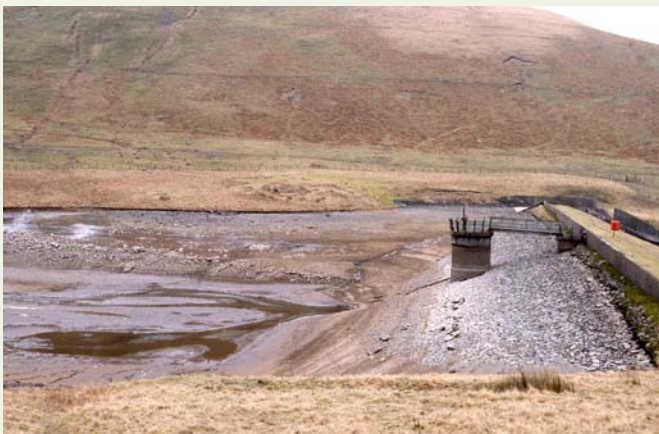
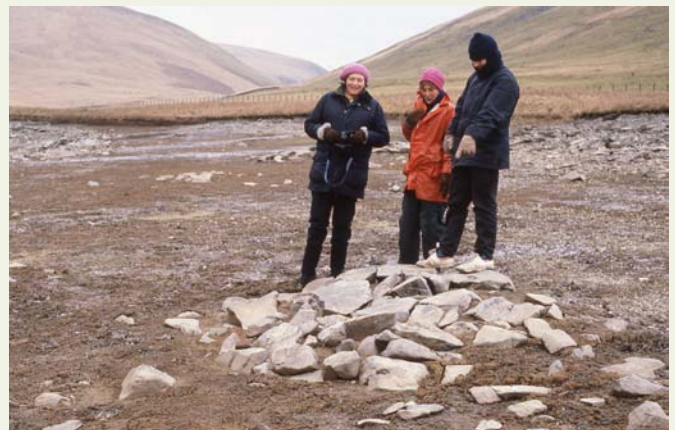
The tiny reservoir of Peden (PI's 31 & 32) is no longer a public water supply. It was investigated in the 1990's by the writer during a period of maintenance and when it was empty. A small cairn group was seen but unfortunately an inadequate record was made of it. There were no erosion problems within this reservoir but the fact remains pre historic features are to found there.

**Plate 31 Peden Reservoir when empty**

**Plate 32 Peden reservoir showing pre historic cairn**

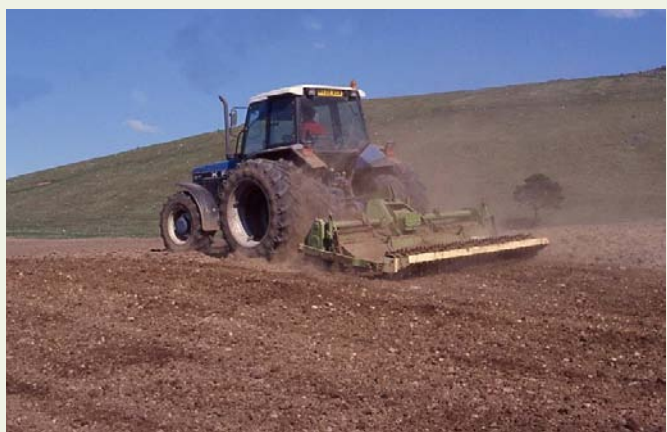
The use of power harrows (PI 37) has a similar effect where the plough soil is thrown up against a cowl; the heavier material drops first and is then covered with the finer soil. Apart from the attrition of objects in the process, searching for lithic on the surface usually proves fruitless because it has been buried below the graded soil.

**Plate 37** Power rotovator in action at Brownsbank Farm

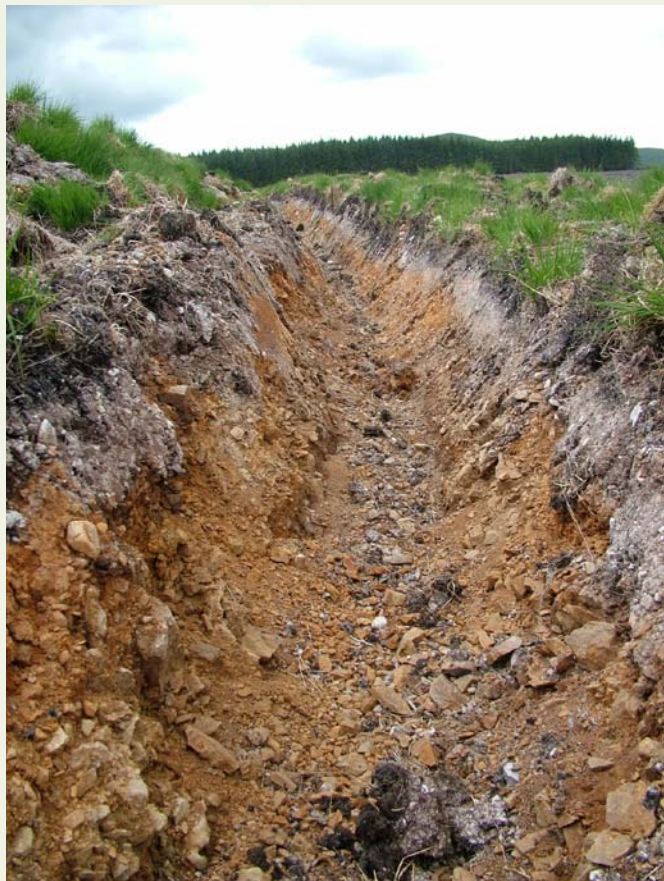
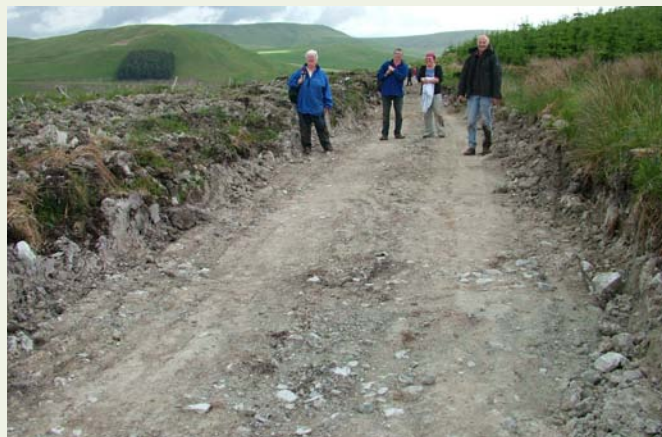
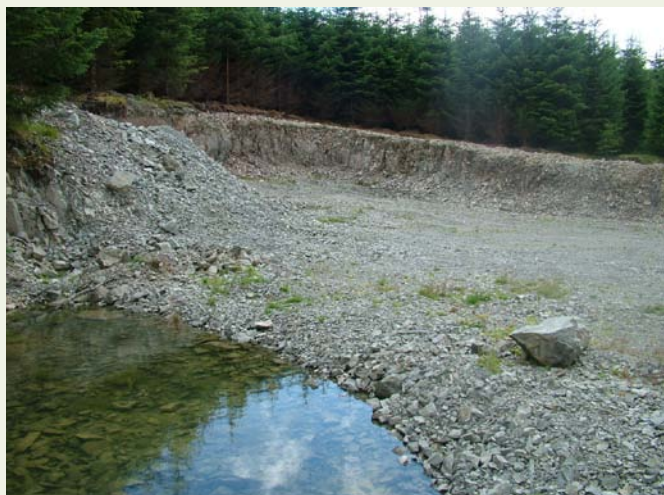
**Plate 42** New drain at Coom Rig forest, Daer valley

**Plate 43** New road at Coom Rig forest, Daer valley

**Plate 44** New quarry at Coom Rig forest, Daer valley

Often new drains, roads and quarries (PI's 42 - 44) are cut and mounding for planting new trees takes place (PI 45). This disturbance offers the possibility to find archaeological deposits, features and objects. The mounds for re planting appear to be large areas of disturbed ground, however in reality the mounds from about a 20m radius are more likely to have come from a single pit and therefore only a small patch of new ground has been disturbed. The digger simply lifts material which is mostly archaeologically sterile till, from a pit or drain and which may be over 2m deep, it then deposits the material around and within reach of the machine's position. The pit which is left is filled with tree stumps which are uprooted for the purpose and this again offers the possibility for making discoveries.

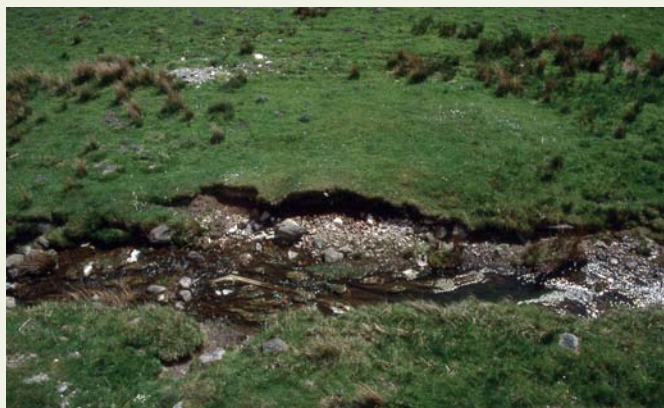
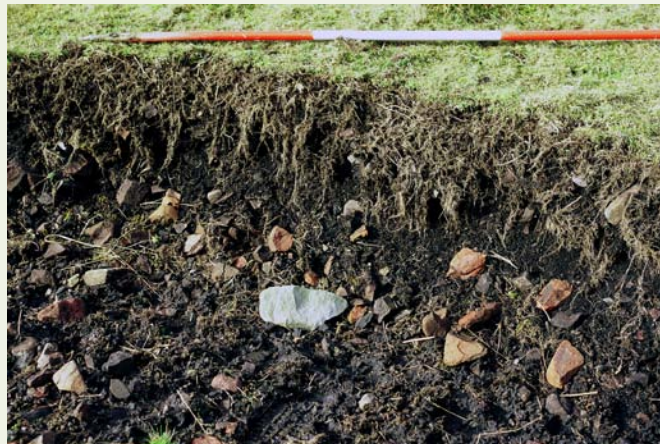
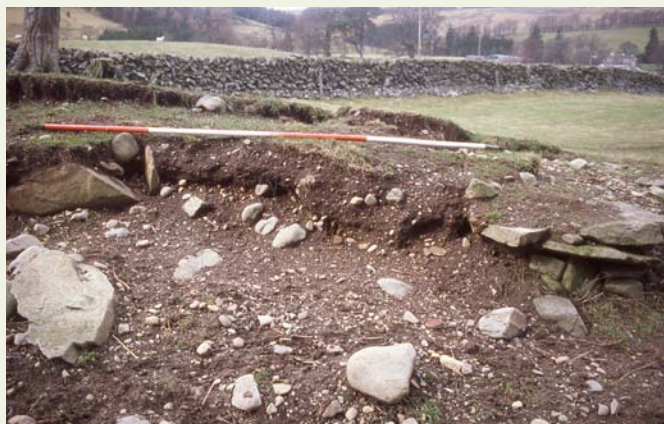
**Plate 51** Burnt mound deposit cut by burn at Crawford

**Plate 52** Burnt mound deposit cut by land slip at Dreva Farm, River Tweed

**Plate 52a** Bronze Age cists exposed by land slip at Mossfennan Farm, River Tweed

The principal cause of such erosion in an inland context is by burn and river systems cutting through sites (PI's 51, 52 & 52a), however, instances of the following are also observed by BAG; wind blown trees, burrowing animals such as rabbits, badgers and moles (often the first indicator that a site exists), ground exposed by other animals, principally sheep and cattle, land slide, weather erosion by wind and rain (PI 53) and finally regarding buildings, decay and ruination caused by weather, falling trees – and neglect (PI 54). All of these have instances where heritage sites have been affected to their detriment.

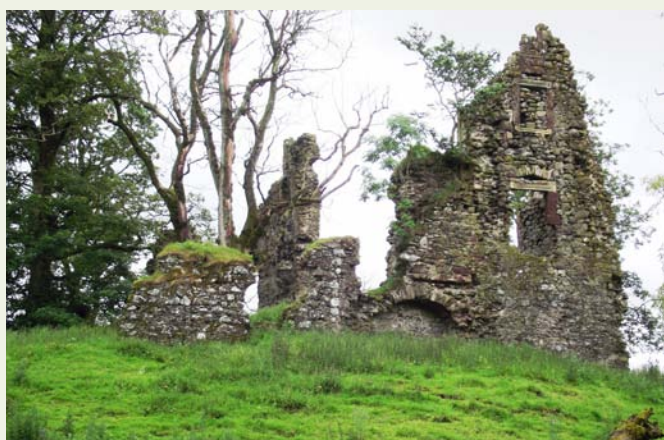
**Plate 54** Crawford castle under threat by falling trees

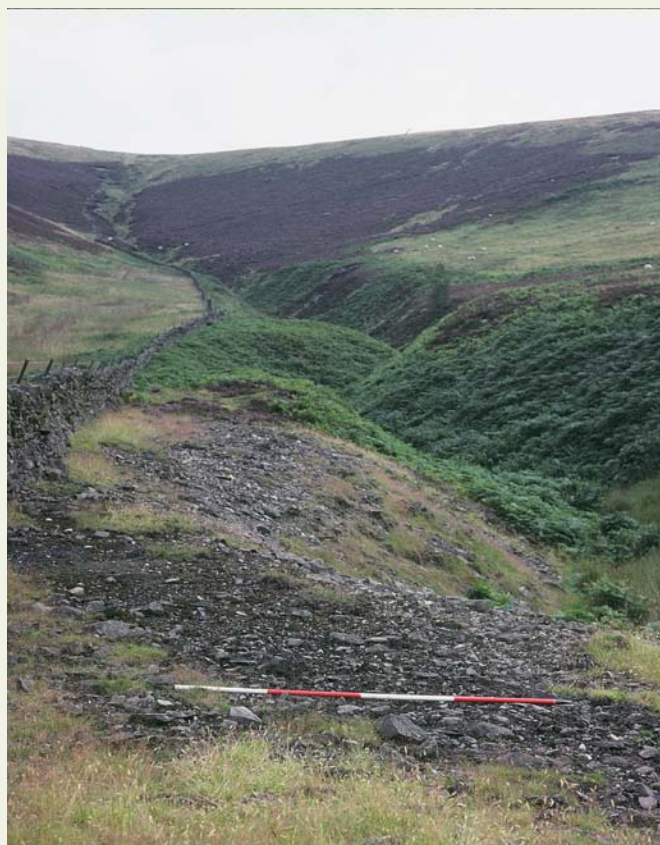
**Plate 53** Lead smelt site eroded by weather at Manor Valley, Peebles

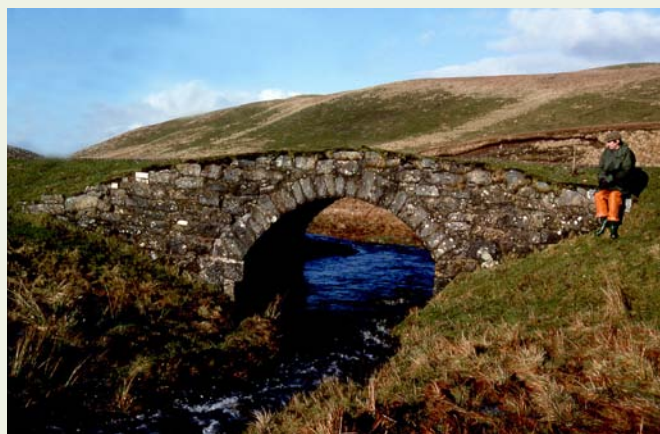
**Plate 57** Paisley Crook pack horse bridge destroyed by M74 construction near Douglas
