Braehead Cottage, Carwood, Biggar

Biggar Archaeology Group

2014-2016

Braehead Cottage, Carwood Hill

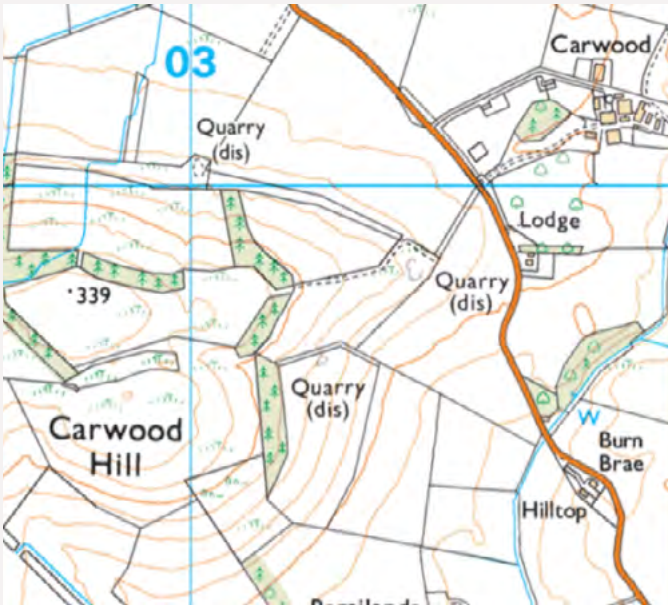
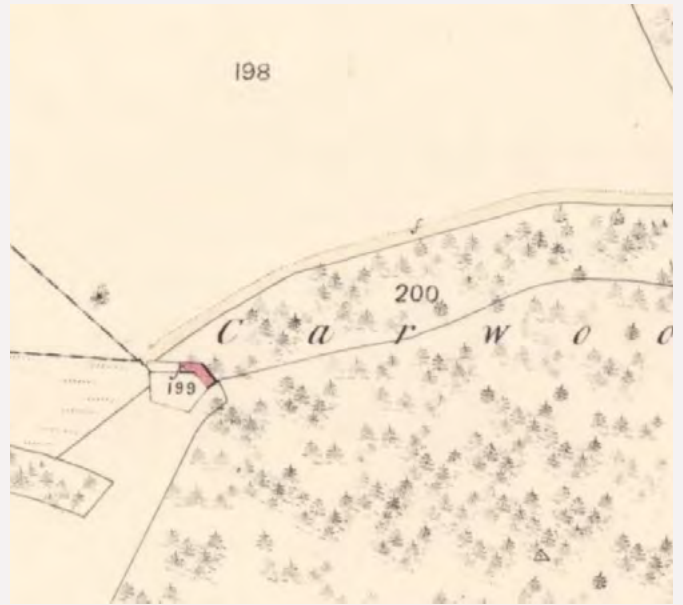
Braehead Cottage on OS 25" 1858

The remains of a mid-18th century building on Carwood Farm, Biggar, South Lanarkshire, are shown on the 25" OS map 1858-88 and are identified on Roy, 1747 as Braehead Cottage. The outline is clearly seen to this day at NT 02754 39590 and is formed of two sections connected at an obtuse angle. Field banks extend from the NW and SE ends of the building.

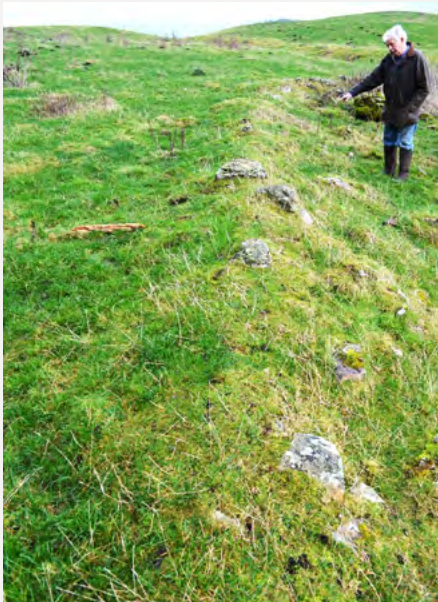
North unexcavated wall of building looking SE

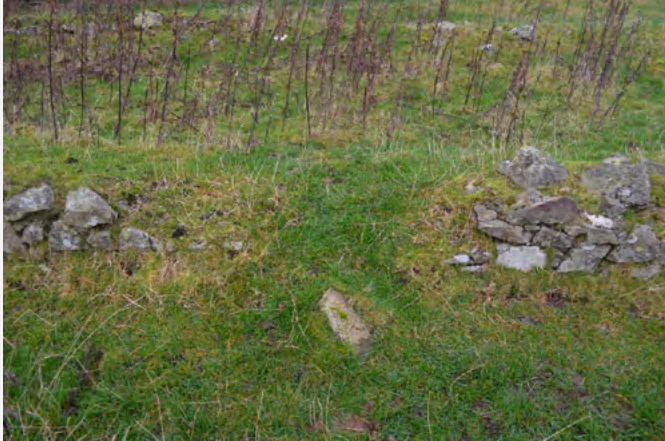
Dip in south wall showing possible entrance

The survey indicated gaps in the remains of the mortared wall and suggested entrances on the south wall, the west end and east end.

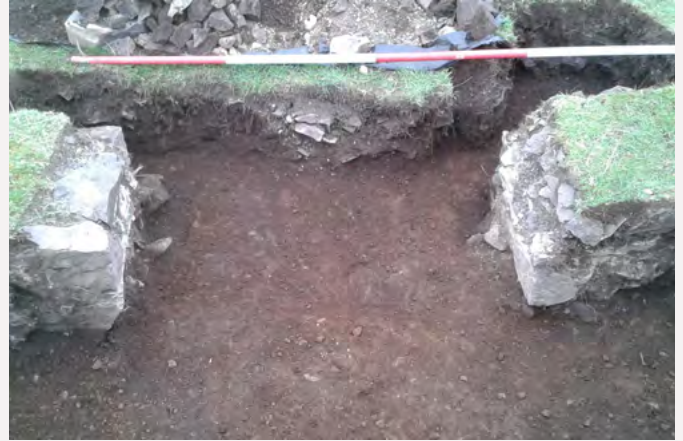
Trench 7 excavated entrance in south wall

The southern coursed and mortared wall was of 0.4m in height and 0.6m width, and at a dip in the wall, a trench (T7) exposed a 1.4m wide space with both sides having neatly squared returns. The inner, eastern corner of the gap revealed a 10cm square recess up the height of the wall and dark staining at the original ground surface (o.g.s.) indicated that a wooden post had been present and that this was a doorway entrance.

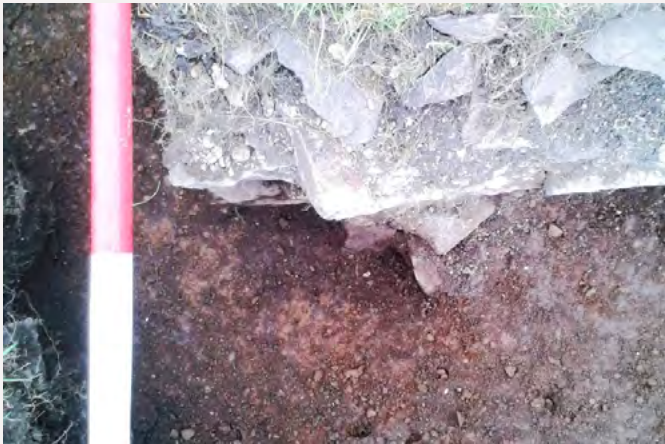
Trench 7 interior door post setting

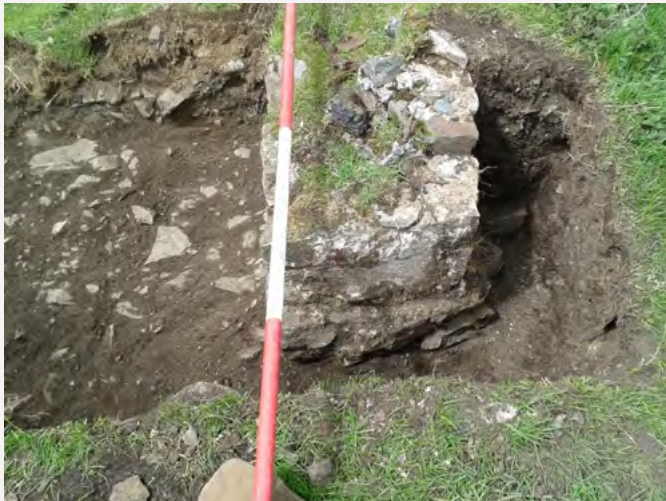
Trench 9 showing end of wall and rough bobbled floor to left

At the south-east section of the building, the ends of the two lime mortared walls were exposed. On the eastern wall a trench (T9) of 2.5m x1.3m was excavated and revealed a wall of 0.6m width and 0.4m height with a squared return. On the 0.4m wide western wall of the building, a trench (T10) also exposed a good, squared return to the wall. At a slightly lower level, an abutted bank wall 0.6m wide, was revealed, made of consolidated stone, and formed the northeast end of the 'garden' bank.

A search of the south-east building for paved surfaces or drains which might indicate the purpose, was conducted by extending T9. The bottom of the trench was of poorly compacted stone and soil and showed no evidence of a formalised floor surface, drain or door.

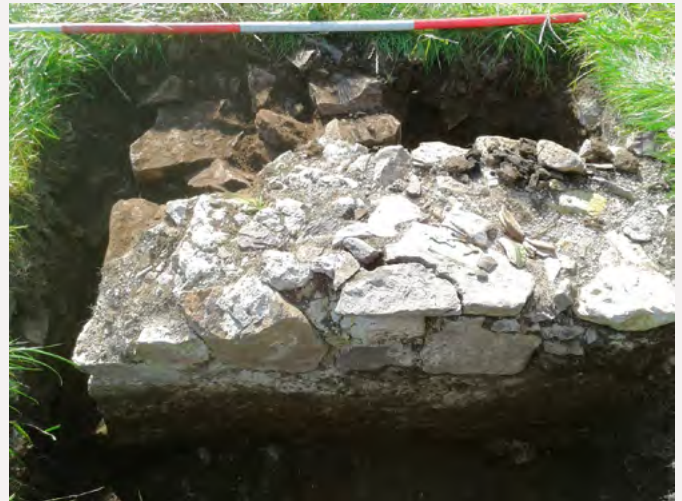
Trench 10 western wall terminal with abutted bank

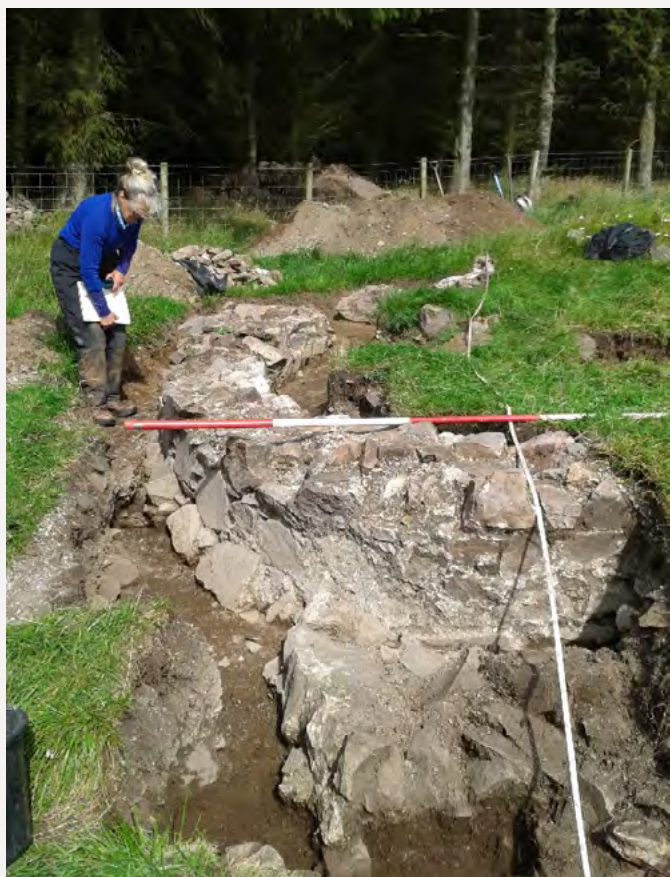
Curved end of wall at T5

At the west end of the building, a trench (T5) revealed a partially damaged semi-circular wall resembling what might be found in a building accommodating a gin mill. The trench revealed a substantially built mortared wall with 0.7m width and 0.3m height, and 7m in length. The semicircle had been breached at the northern corner and the remains of 6 modern fenceposts indicated demolition and a loose fill at this point. At the centre point of the curved wall a gap of 0.7m wide with good, squared returns had been built but had been infilled with substantial stones. The original purpose of the gap was unclear. The possibility of a pony powered gin mill, or drain was investigated by searching for a pad or similar at the radial centre of the circle, but nothing was found.

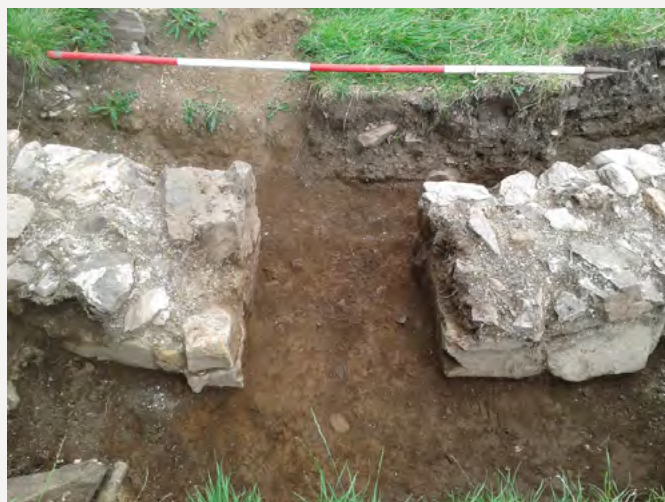
Gap in curved end of building, T5

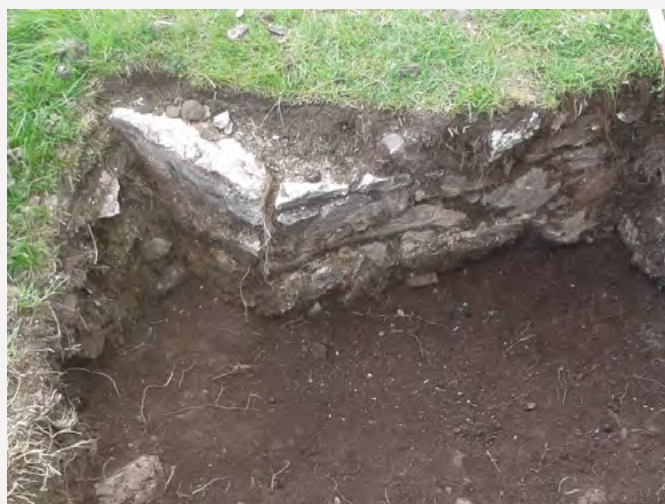
Trench 8 exterior obtuse corner looking SW

The survey had confirmed an obtuse corner join between the two wings of the building and to determine the nature of the wall joints and look for evidence of an internal dividing wall, a trench (T8) was excavated. The two wings of the building met at an angle of 120° but showed no interlocking stones and there was no evidence of an internal wall.

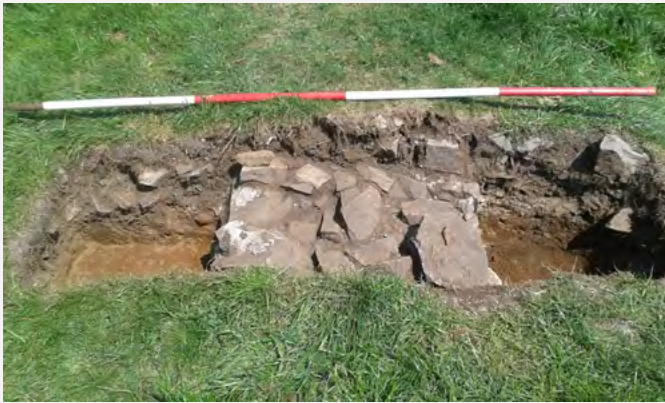
Trench 1 showing earlier building underlying garden bank

At T1, a straight edged wall 0.9m wide and 0.4 deep was exposed after the removal of the loose stone mound. The wall consisted of reused stone with mortar fragments attached and was loosely consolidated with soil and not mortar bonded. The southeastern, outer edge of the wall was exposed by a 0.2m wide trench between T1 and T2. A substantial rectangular spread of mortar was underlying the middle part of the exposed wall. The southern corner of the bank was excavated 2.0m from T3 at trench 4.

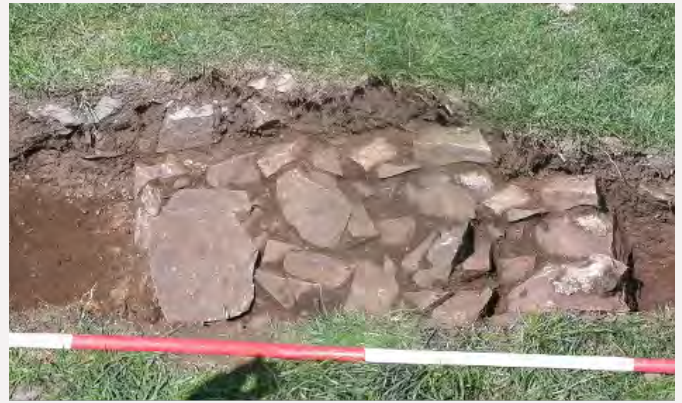
Trench 2 showing mortared wall underlying stone 'garden bank'

Where dips in the bank were surveyed, trenches T2 and T3 were excavated to explore a possible entrance. Removal of the loose stone mound at T3 revealed a good, squared return on a lime mortared wall 0.6m wide, 0.27m high. A spread of lime mortar extended below the base of the wall into the base of the trench. Trench 2 exposed an un-mortared setting of stone 0.4m northeast of T3 which formed the ragged end of a more poorly consolidated section of the bank wall. This appears to indicate the presence of a building pre-dating the garden bank.

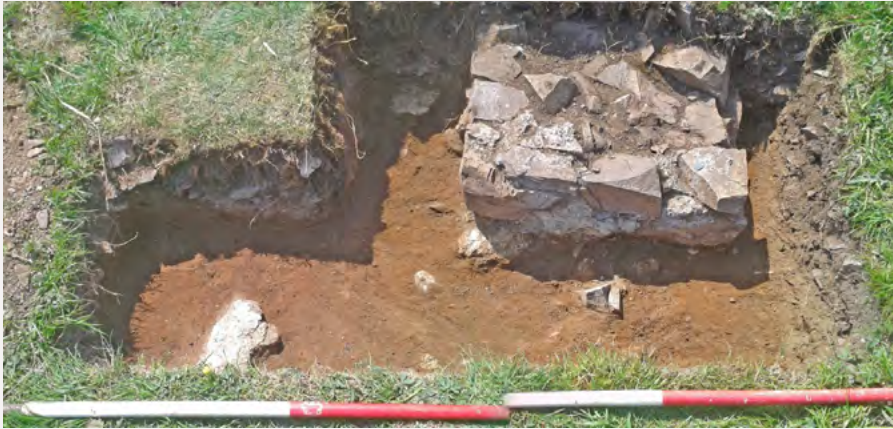
Trench 3 looking SW; entrance to building pre-dating garden bank

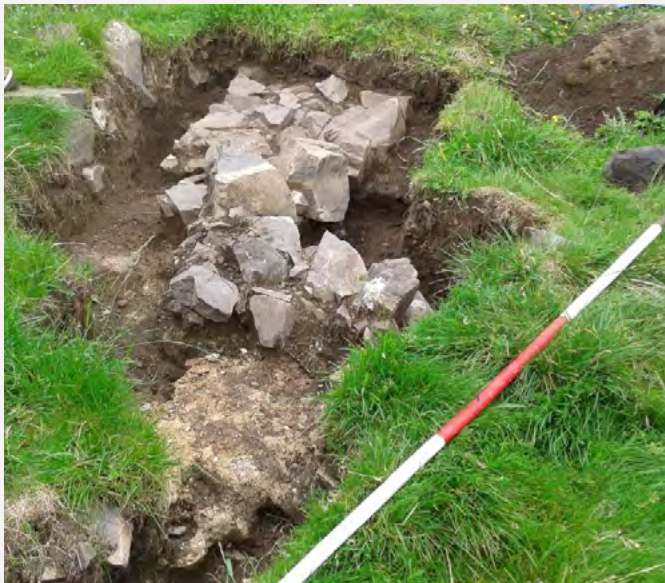
Trench 4 – contrasting building remains beneath garden bank

The wall at T4 was variable in the quality of construction, being more uniform on the northwest wing. The corner joint appeared to be of loose infill to a robbed or damaged area. A substantial lime mortar patch of 1.5m x 0.6 m and 0.2m thick underlay a part of the northeastern wing of wall, being present on both sides of the wall. Trench 4 – contrasting building remains beneath garden bank
